# *Little Goose Dam*

## *Radial Gate Inspection and Testing*

US Army Corps of Engineers, Walla Walla District

13. ABSTRACT (Maximum 200 words) This report is an evaluation of the overall condition of the spillway tainter gates at Little Goose Lock and Dam, Snake River Washington.				
20030313 194

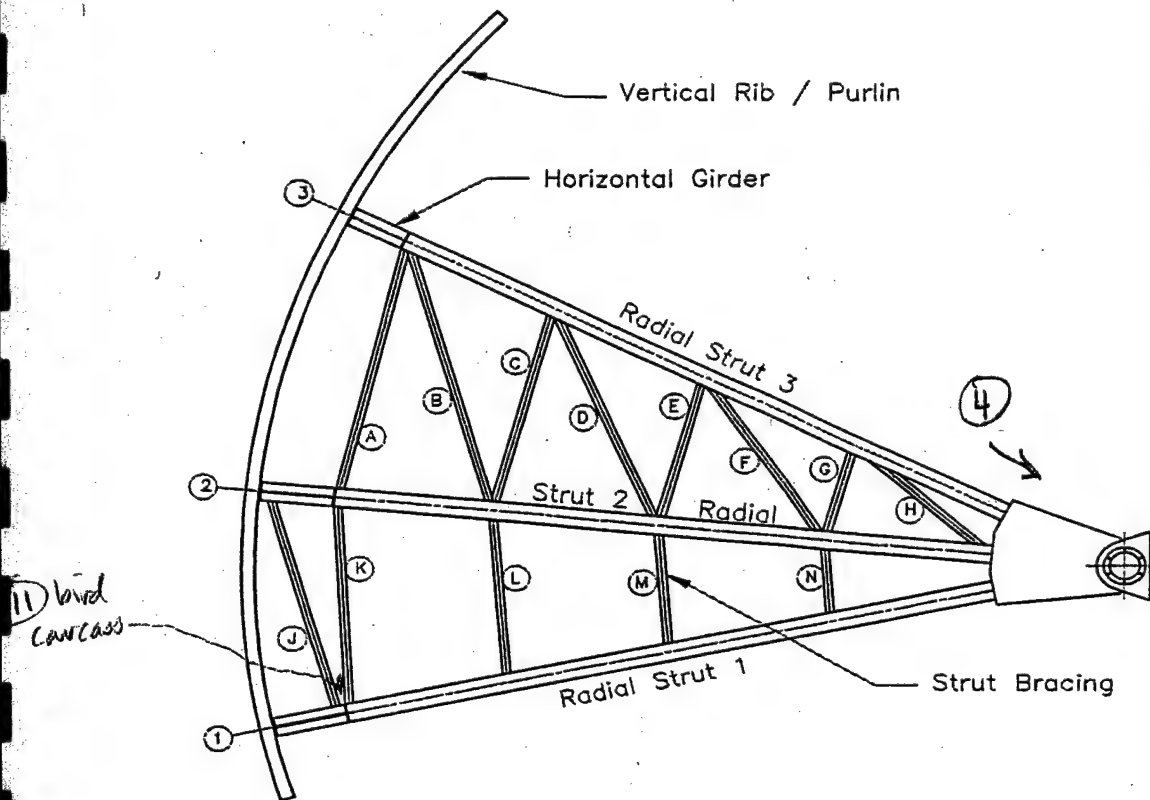
Gate No. 2  
Left Elevation B-B

⑨ US side of brace N  
typical light  
surface rust

⑭ entire frame  
from bottom  
horiz

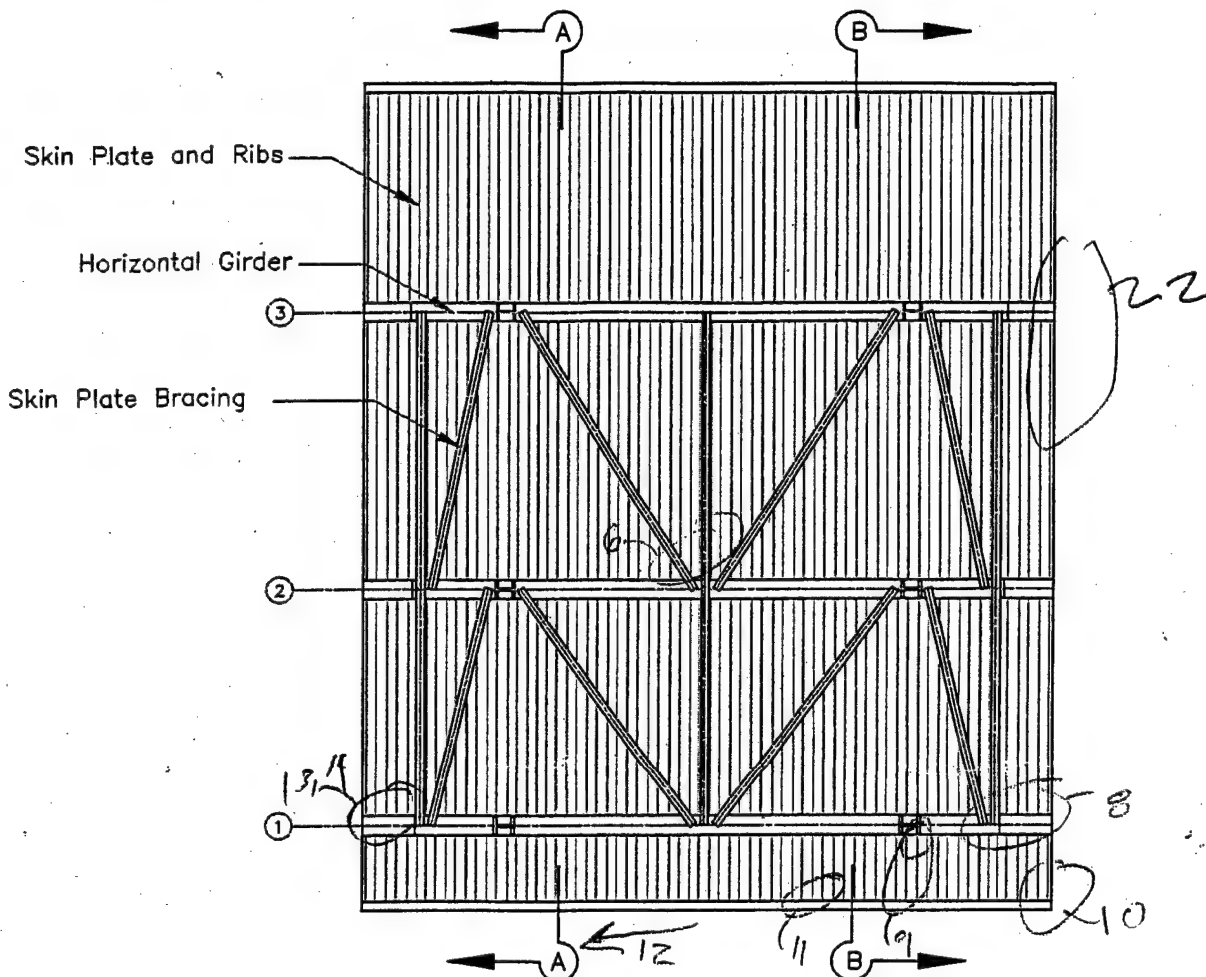
Gate No. 3 Downstream Elevation

2. LEFT Purlin light rust w/ min deposits

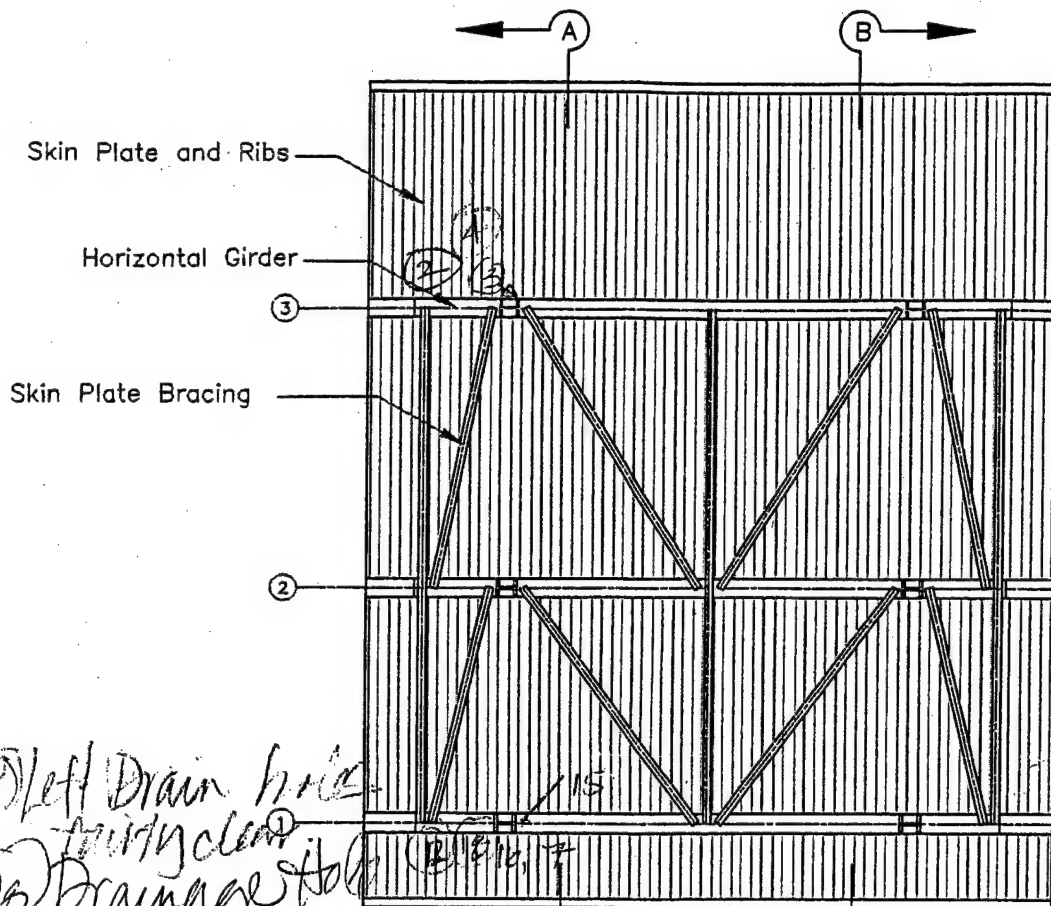
Gate No. 4 Downstream Elevation

- ① Gate No. 4
- ② Light Rust on purlins + riv.
- ③ Stiffeners not welded to gate face, riv. connecting in ends.
- ④ Rivet, Bottom Seal.
- ⑤ Strange Divots and paintless marks top on skin plate.
- ⑥ Light Rust on Vertical Braces.
- ⑦ Ponding Water Bottom Girder.
- ⑧ Before, Corrosion Spots + ⑨.
- ⑩ After.
- ⑪ Corrosion Water, Bot seal, center.

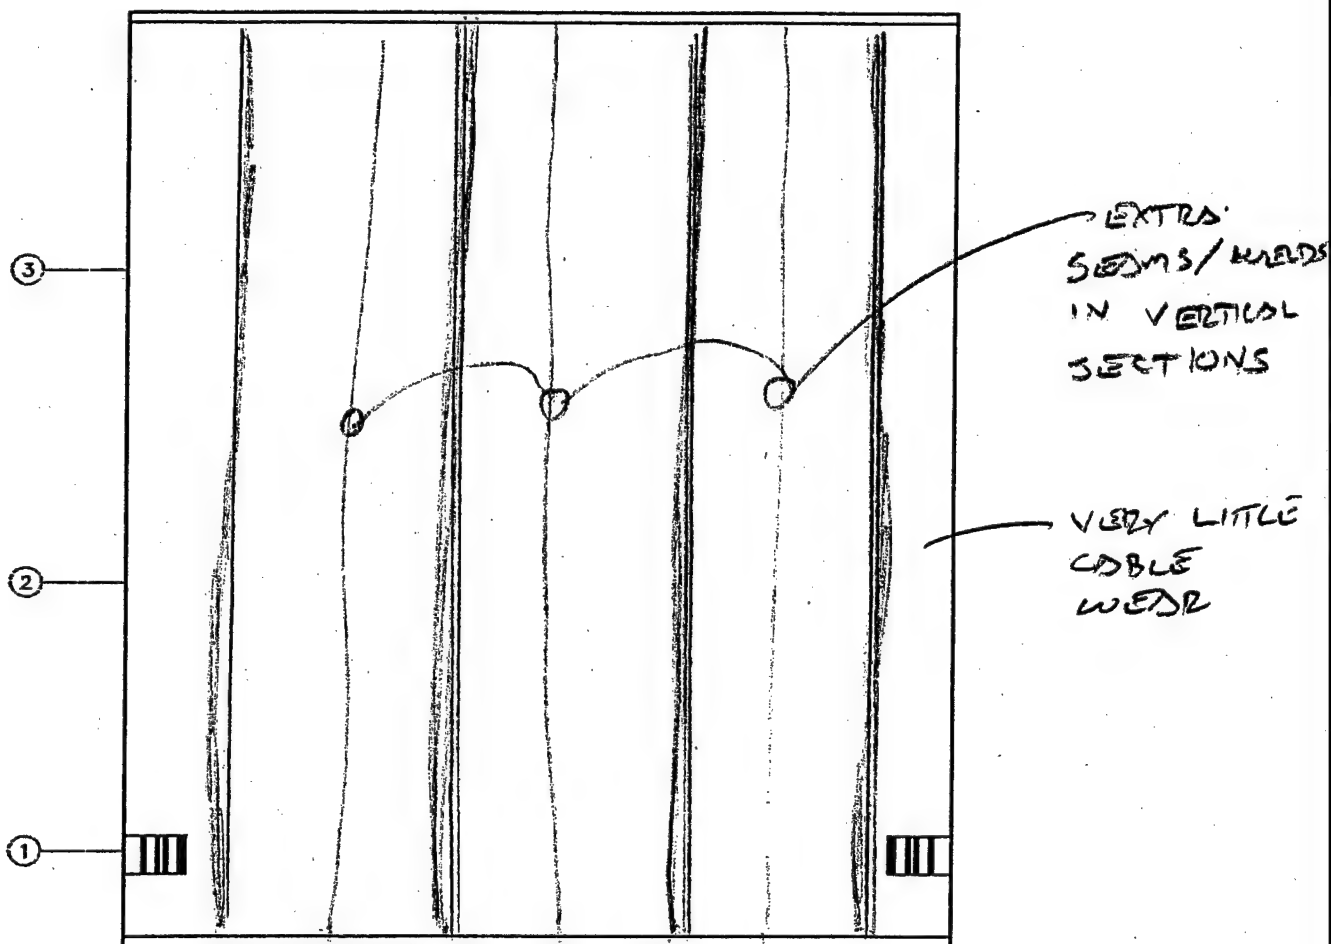
Gate No. 4 Upstream Elevation

- TYPICAL PITTING, LIGHTER THAN USUAL

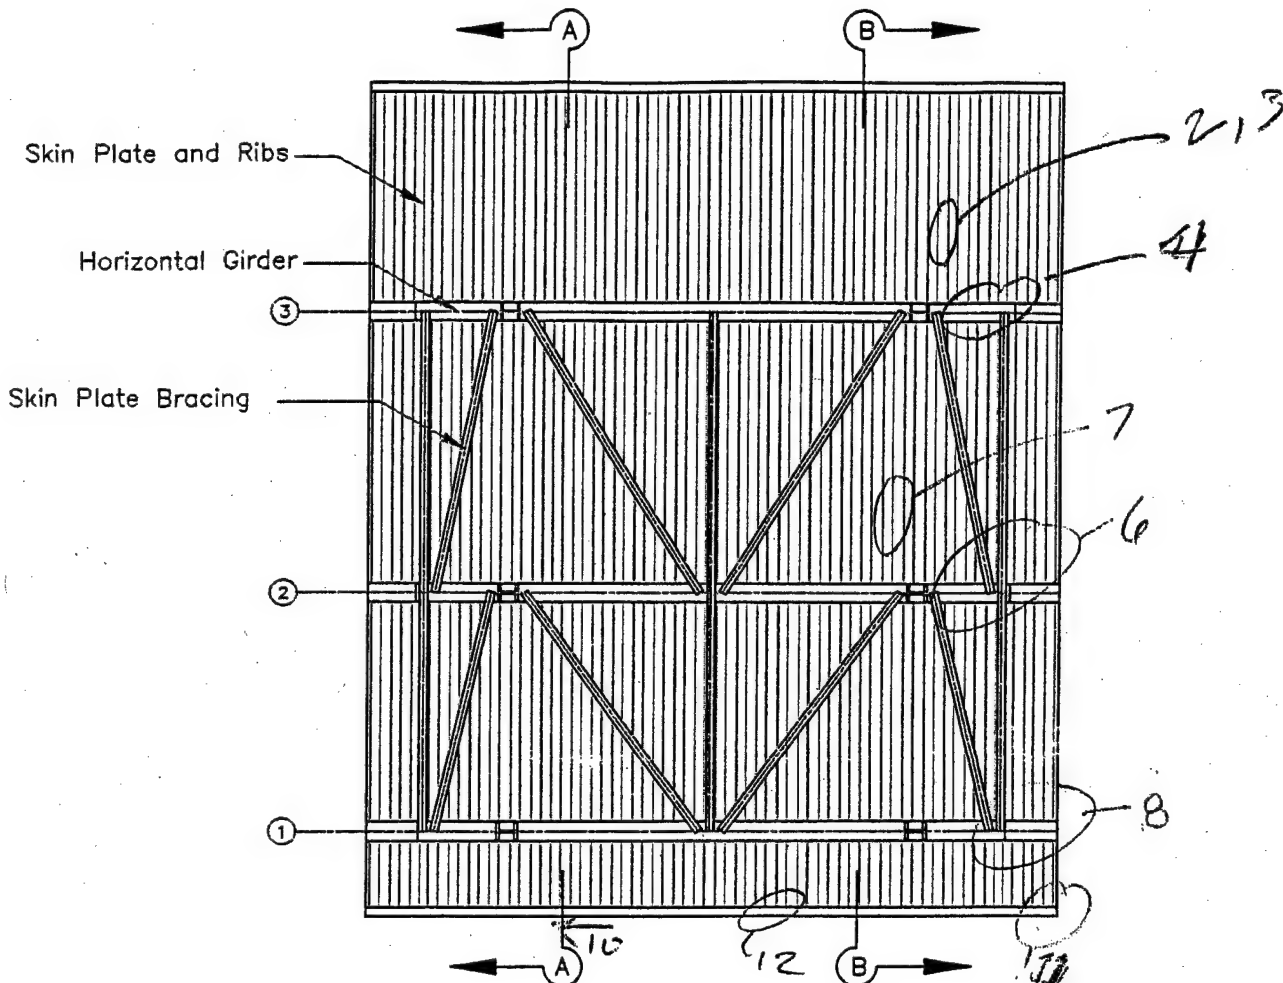
Gate No. 5 Downstream Elevation

- 2, 3. Delaminated Pnt and light Rust ON GATE FACE
4. Light Rust TOP GIRDER
6. Light Rust ON GIRDERS AND BRACES NOTE Delam ON GATE FACE
7. Delam. ON GATE FACE w/ light Rust. These Delam spots ARE TYP ACROSS ENTIRE GATE FACE.
8. SIDE SEAL LEAK @ Bot GIRDER NOTE Light Rust & MINOR / Dep.
10. Bottom Seal looking Right
11. LEFT CORNER leak
12. Bottom Plate w/ STANDING H<sub>2</sub>O

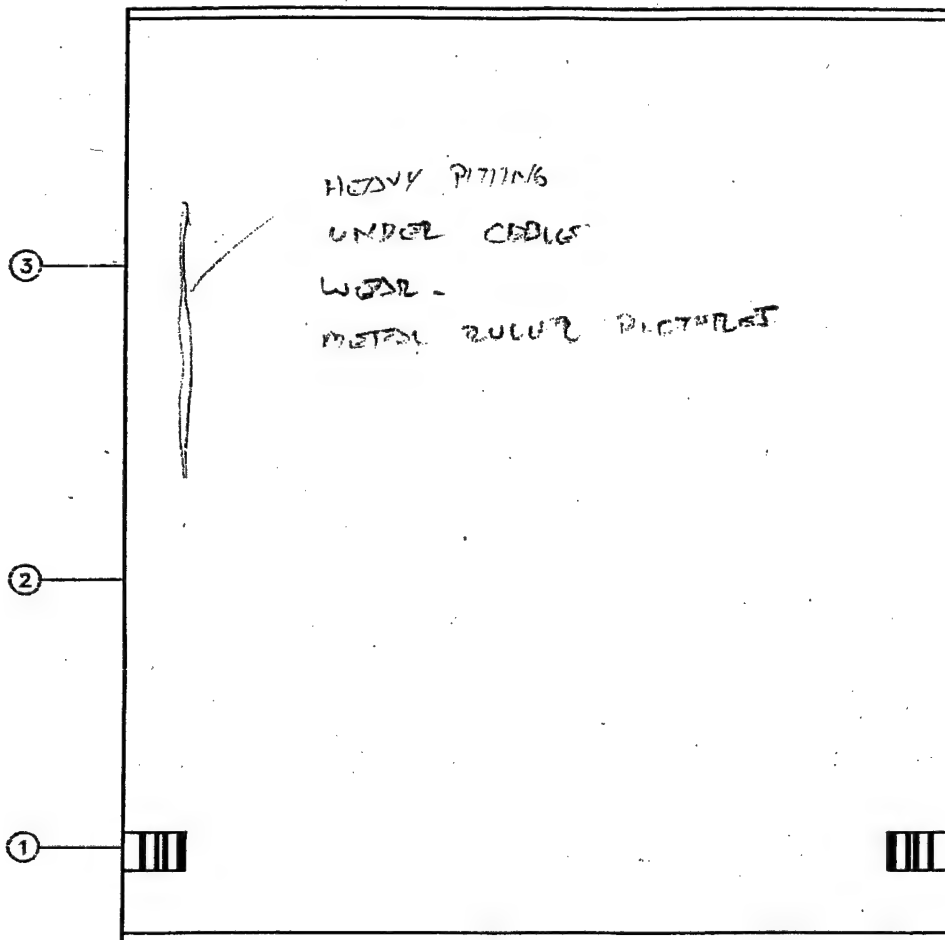
Gate No. 5 Upstream Elevation

- BEST CONDITION OF ANY GATES SEEN
- MINIMAL PITTING
- EXCESSIVE STOP LOS WEAR, COULD NOT GO UNDER SILL DO TO FALLING WATER -

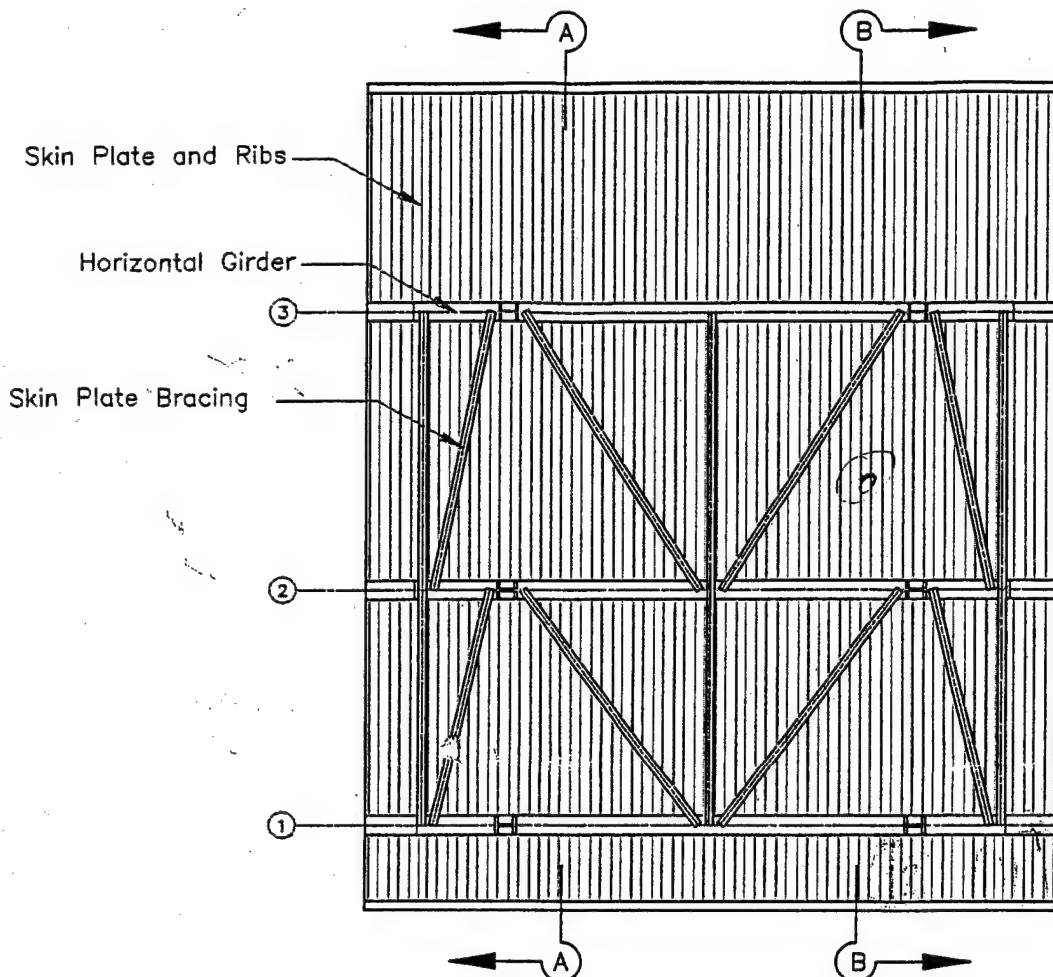
Downstream Elevation

(10) (20) Leak in middle, water coming through hole

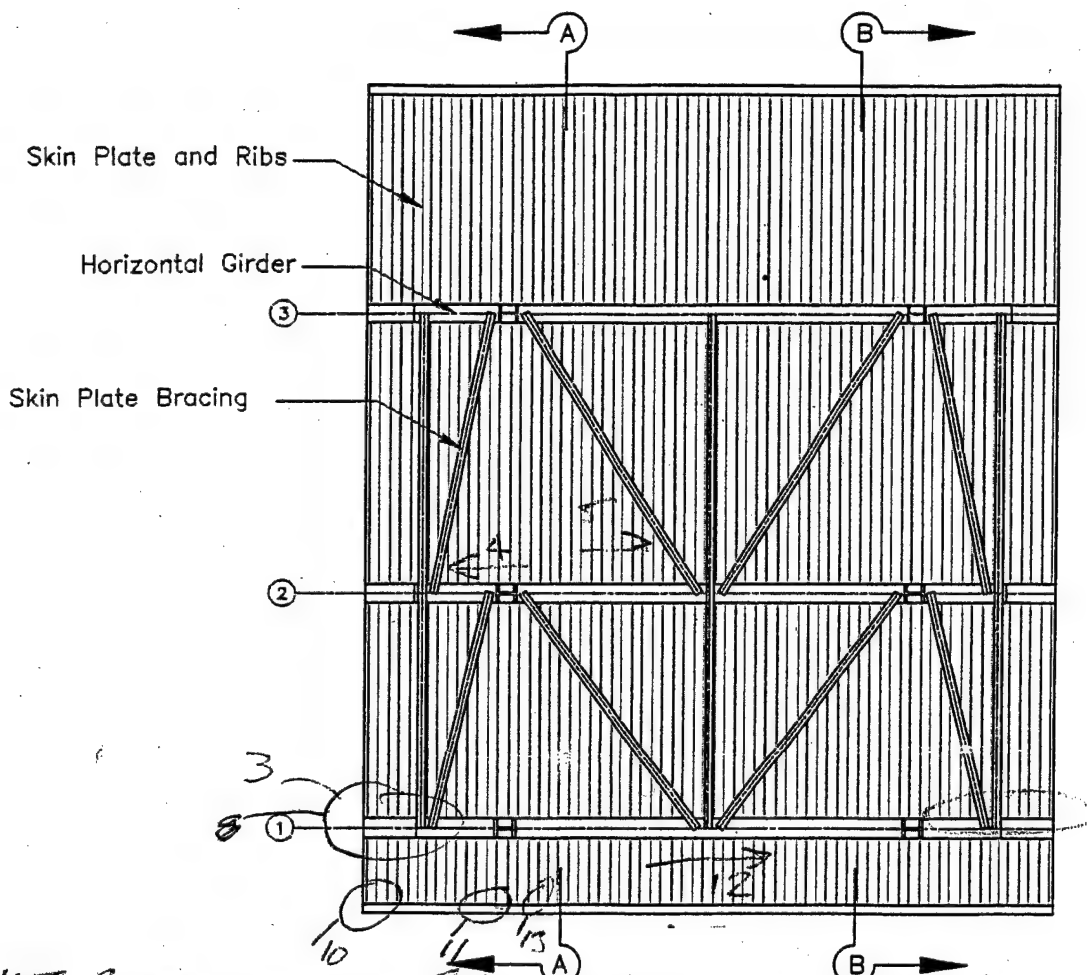
Gate No. 7 Downstream Elevation

NOTE. PAINT ON GATE FAILING. FLAKY W/ LIGHT RUST

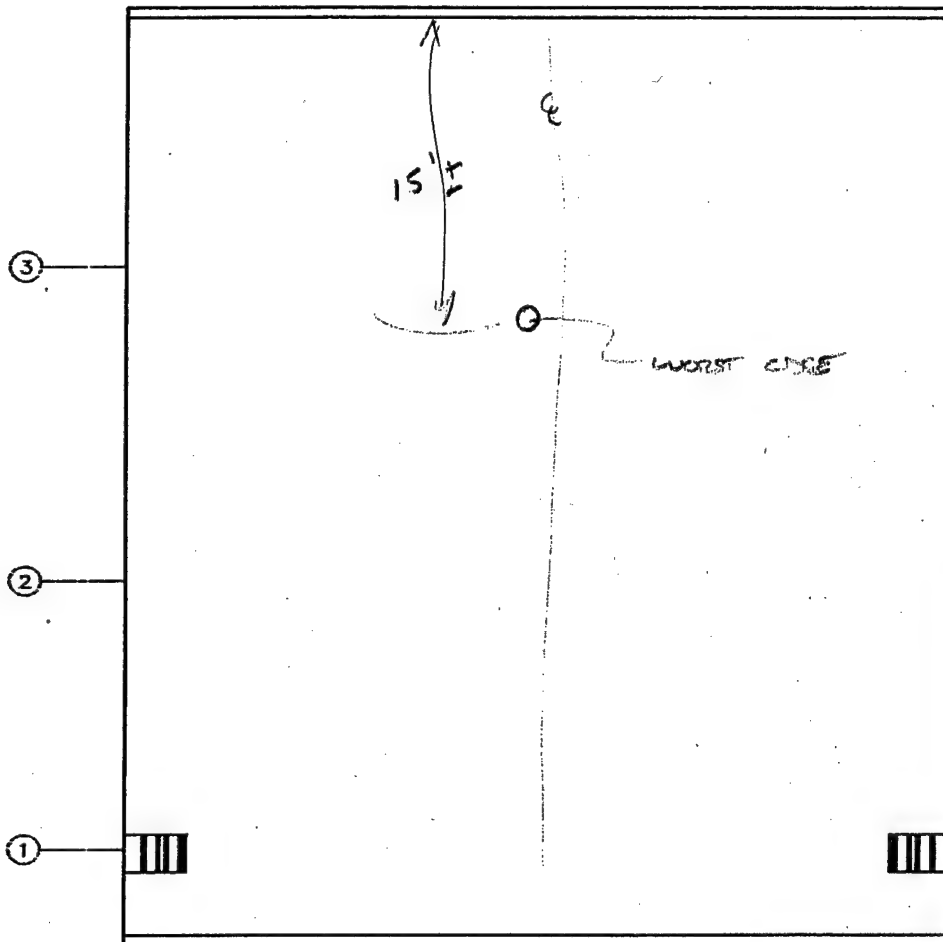
Gate No. 7 Upstream Elevation

MUCH BETTER CONDITION THAN GRANITE

EVIDENCE OF POST WELD & GRIND

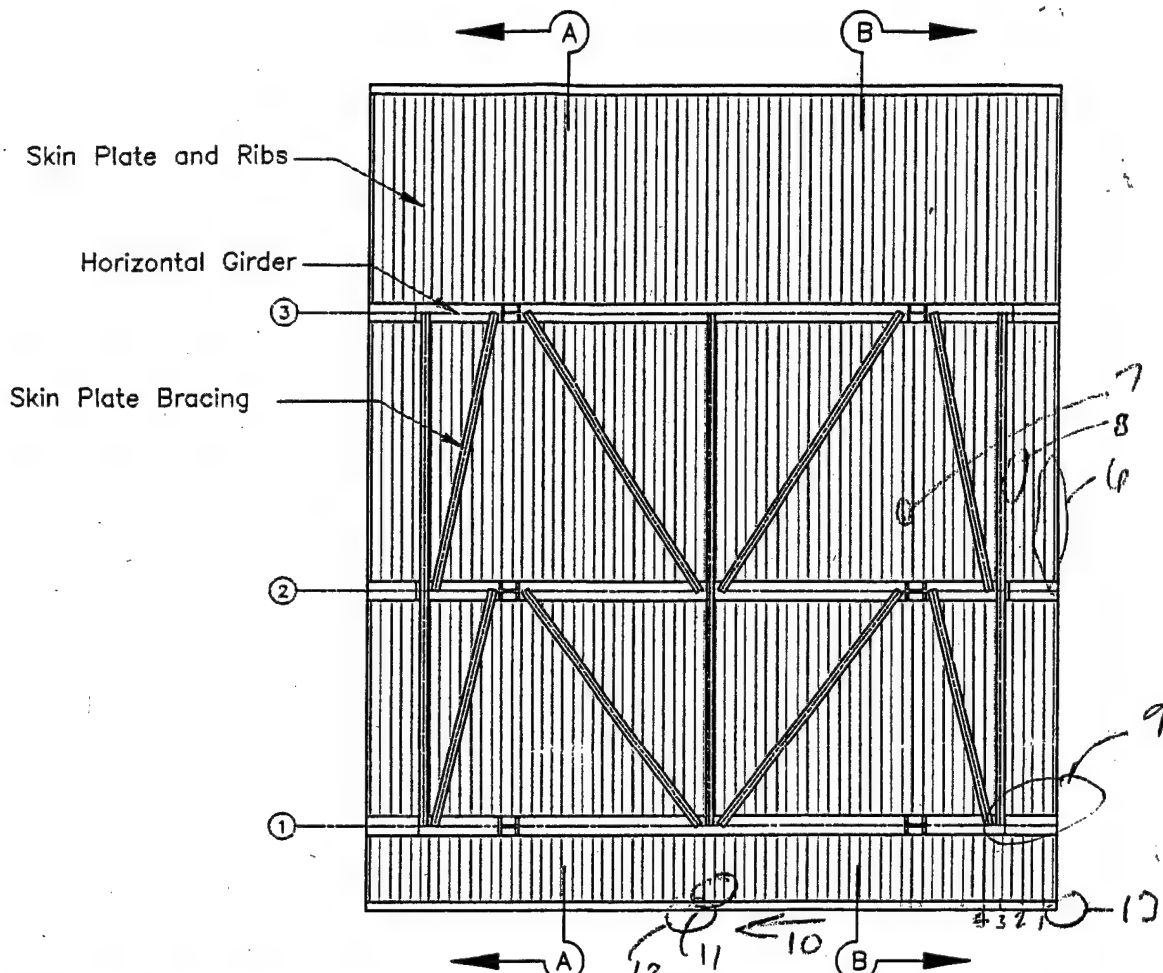
Gate No. 8 Downstream Elevation

NOTE: ENTIRE GATE is Peeling w/ light RUST. there is evidence of NEW PAINT @ V. GATE FACE PL.

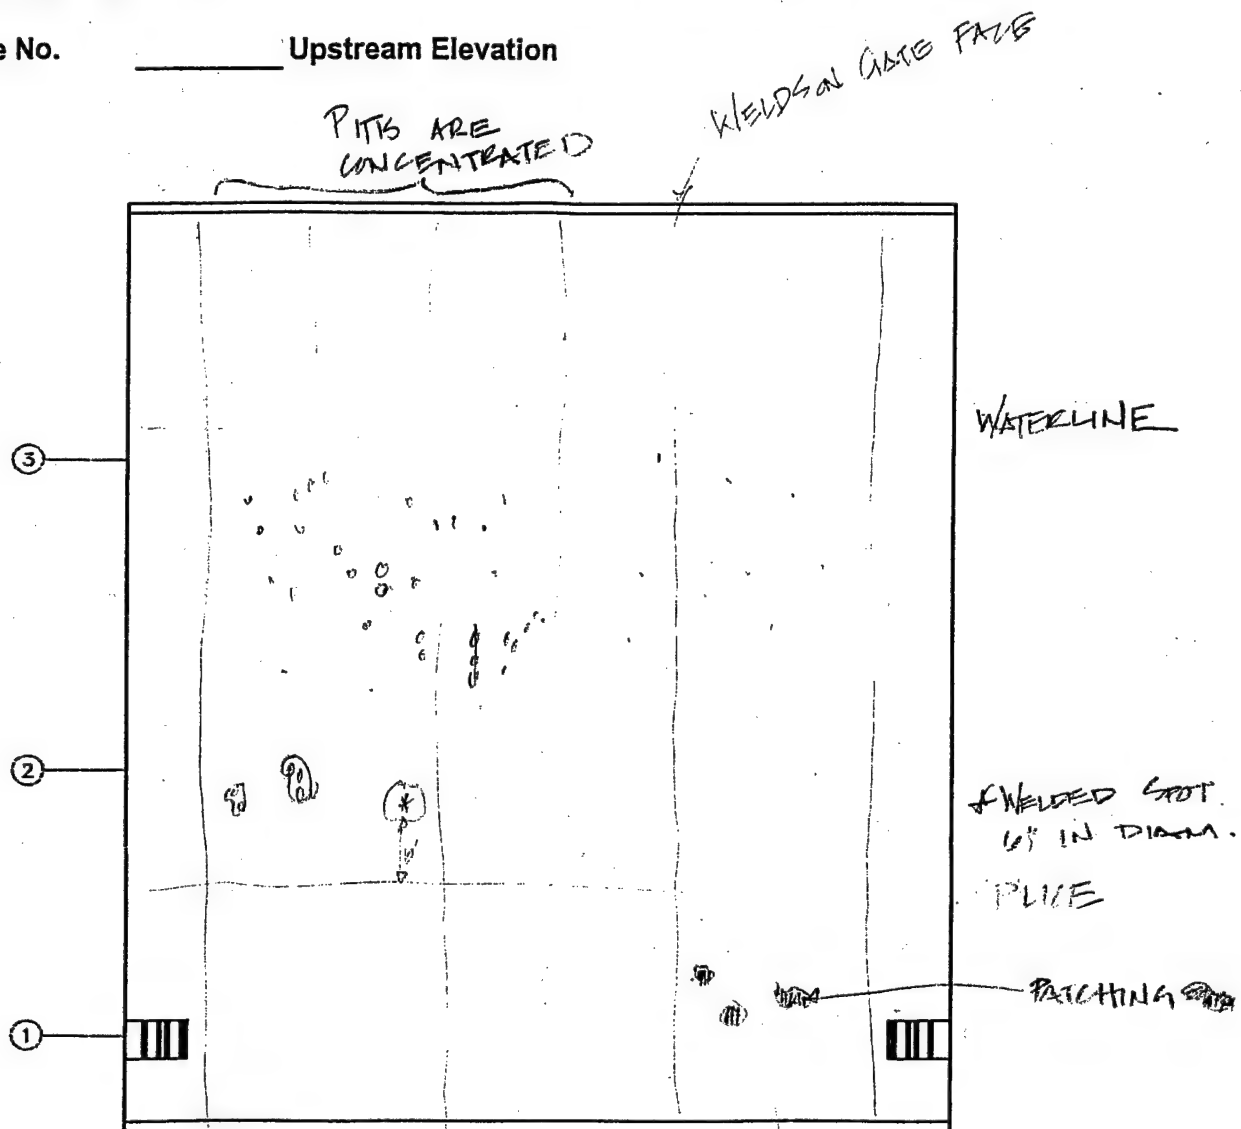
Gate No. \_\_\_\_\_ Upstream Elevation \_\_\_\_\_

- SOME PITS HAVE BEEN FILLED W/ WELD MATERIAL
- RECORDS SHOULD BE REFERENCED
- OTHER PITS ARE EXISTING
- SMALL PITS
- WEAR PLATES LOOK CLEAN

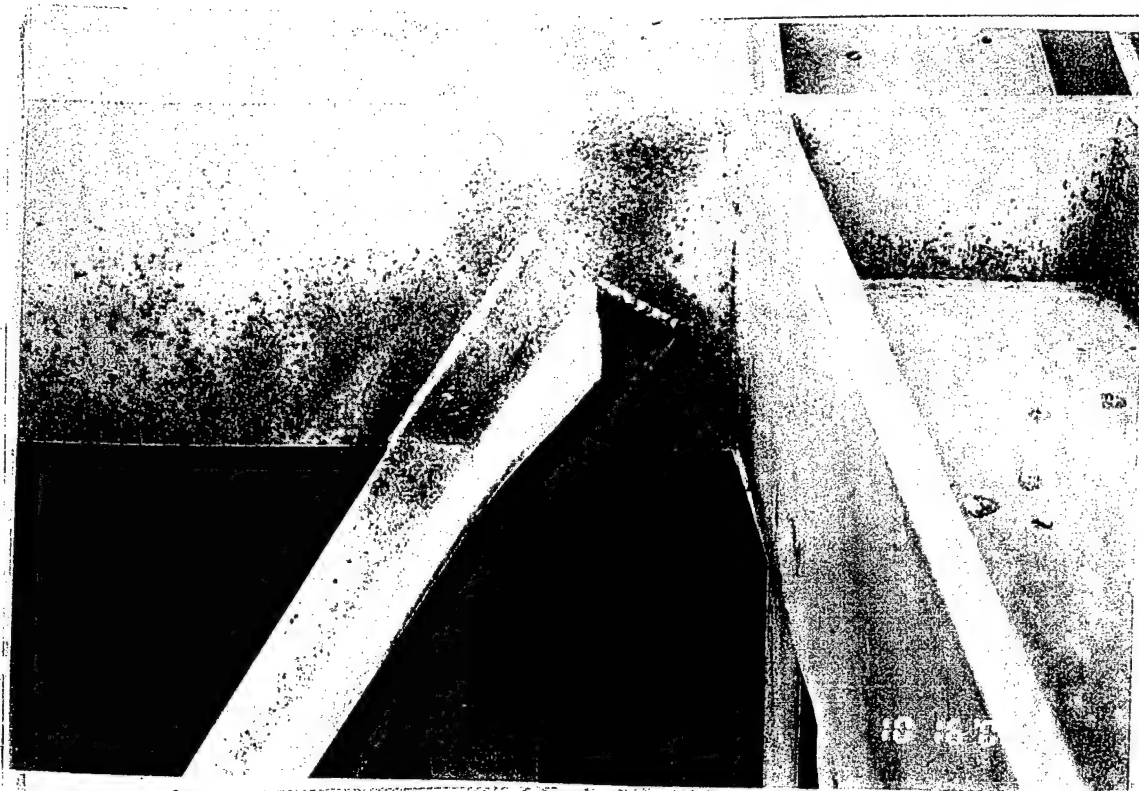
Skin plate at center of gate, 5' above  
top horizontal girder. Apparent  
previous weld and grind repair.

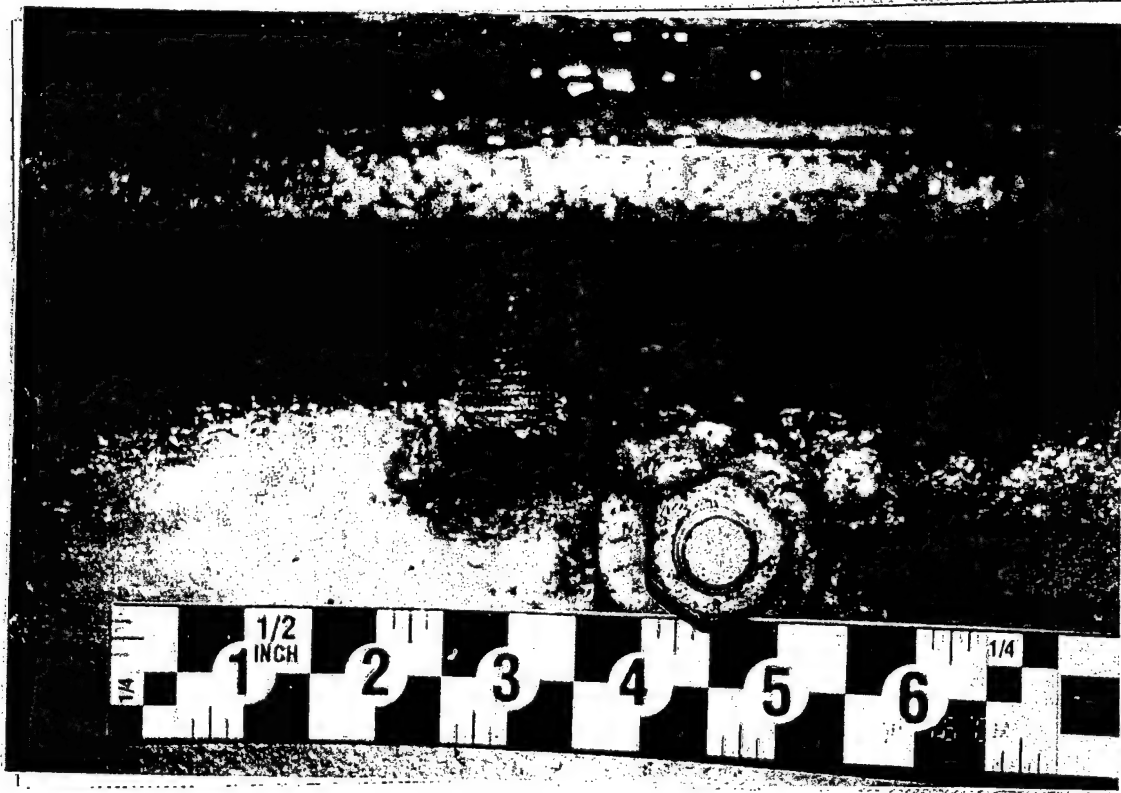
Side seal, typical. Light to moderate corrosion on skin plate, side seal angle, nuts and bolts.

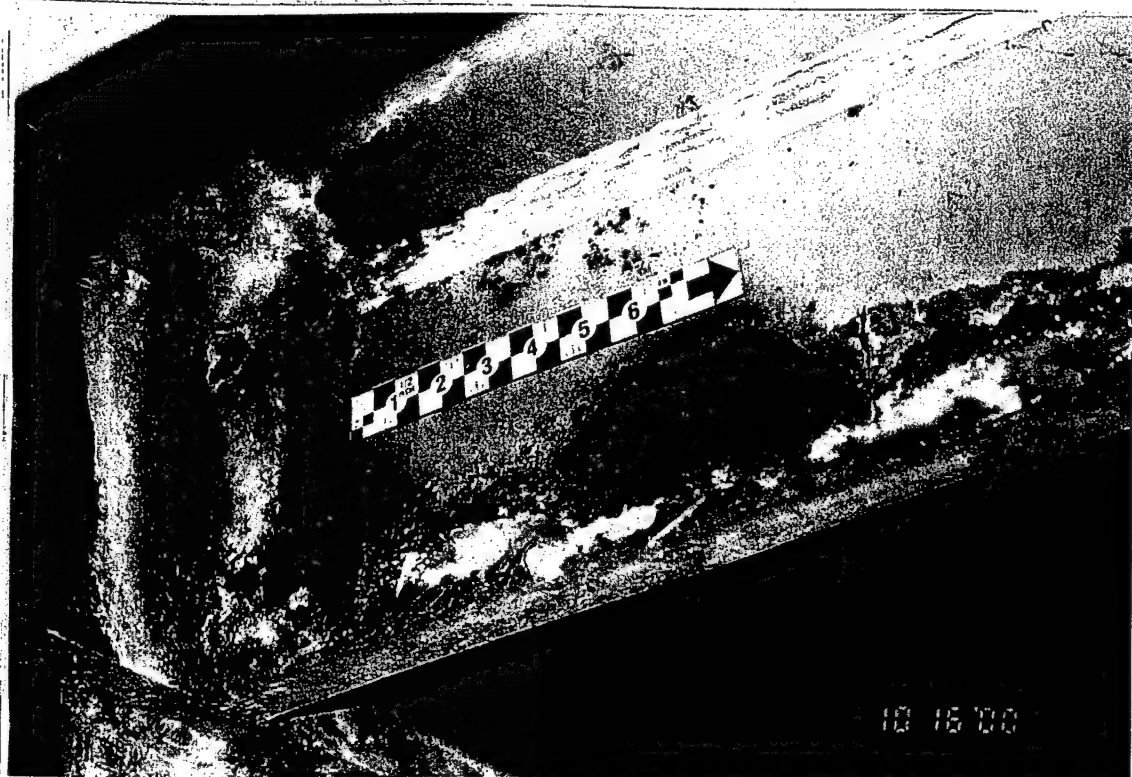
**Gate 1**  
Bottom seal closure plate looking  
upstream. Standing water between  
closure plate, purlin webs and  
skinplate. Typical.

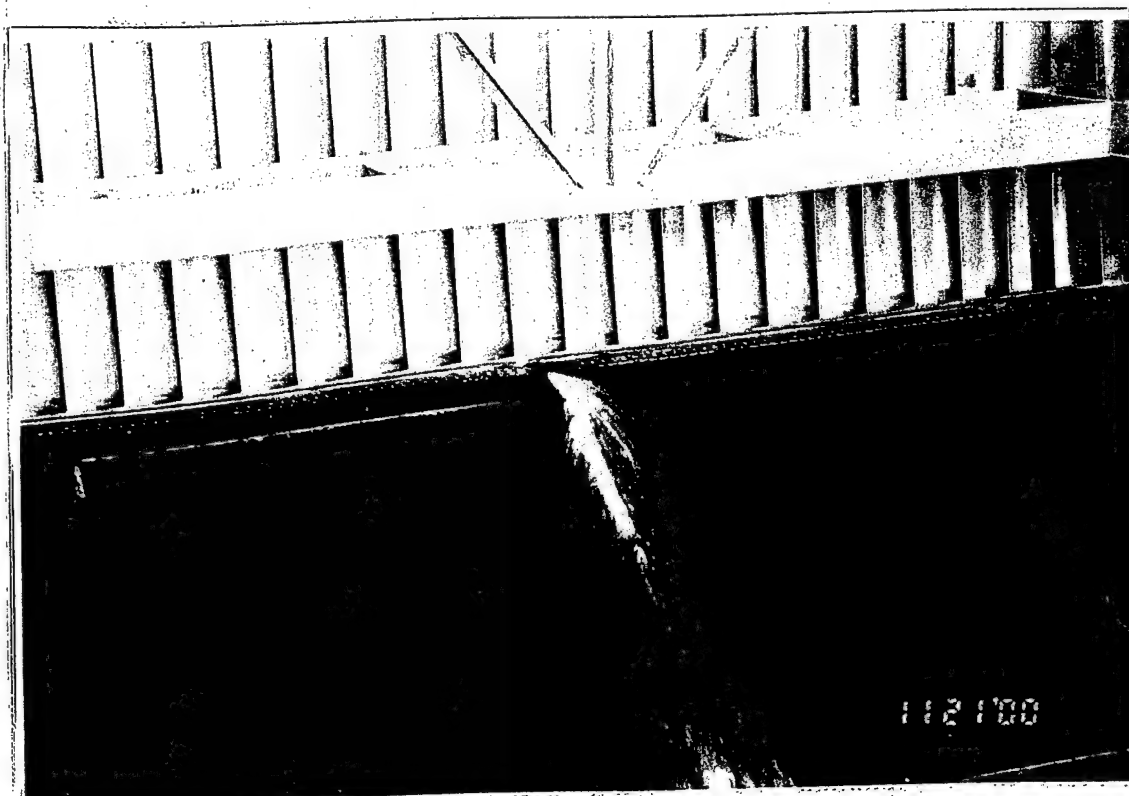
1-23

Gate 1  
Leak at center construction joint in  
spillway monolith.

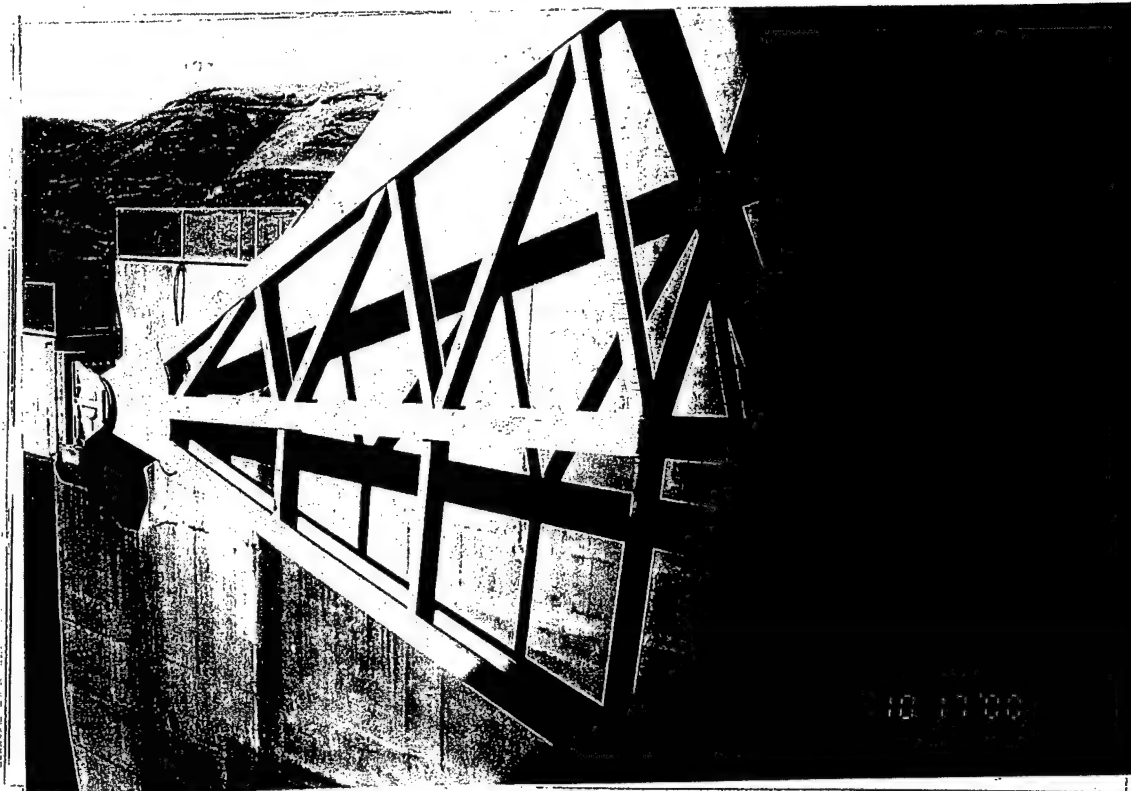
Side seal leak, right end of bottom  
horizontal girder.

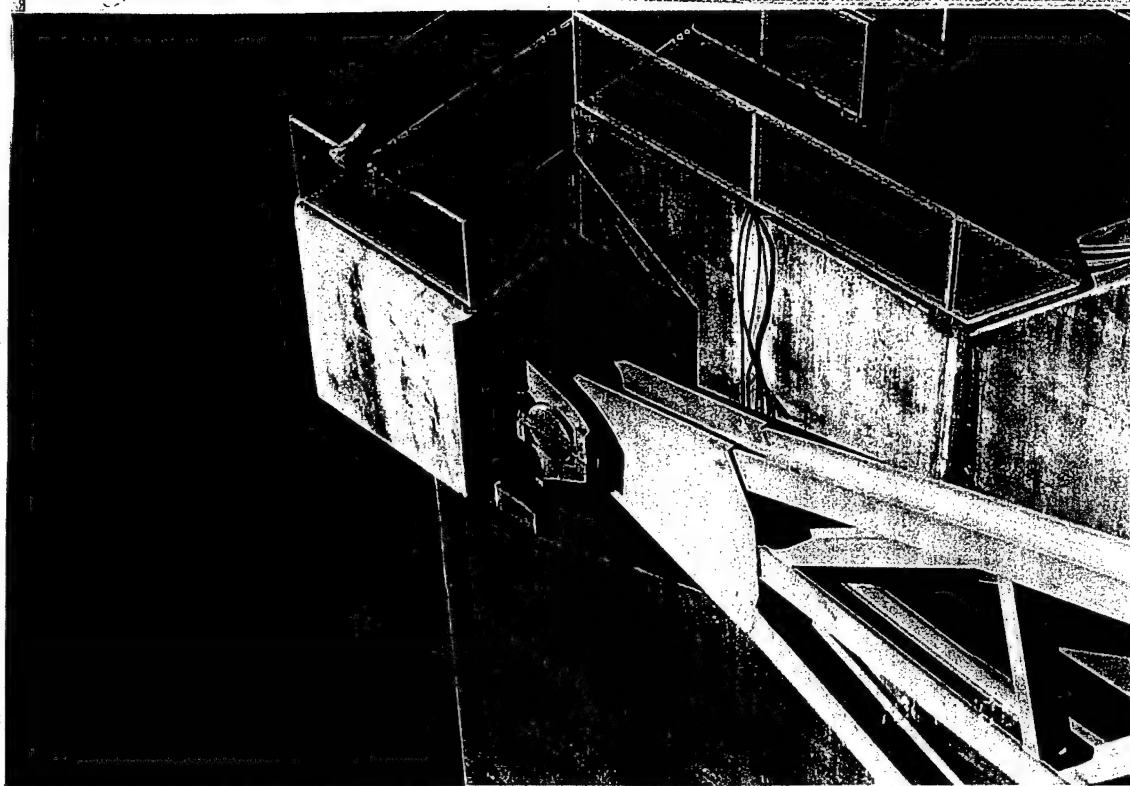
**Gate 2**  
 Side seal leak, right side of gate.

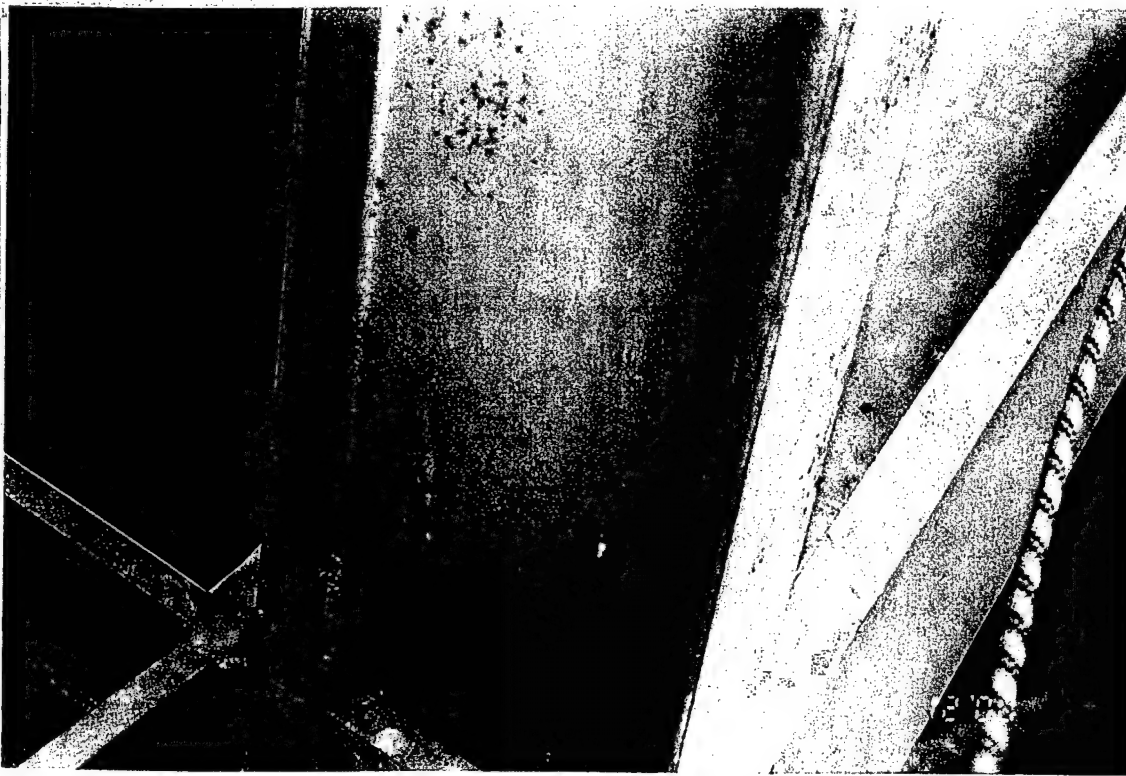
3-3

Gate 3  
Left frame, Brace A. Light corrosion  
on upstream side.

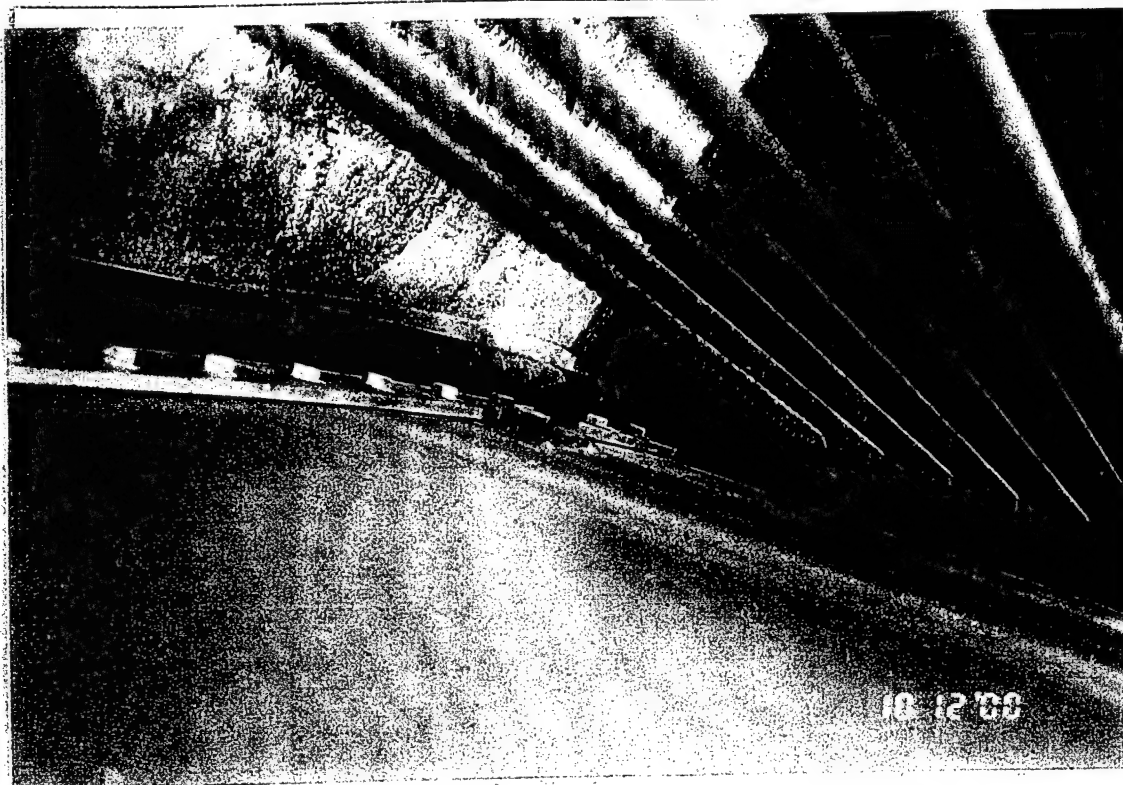
3-15

Gate 3  
Top upstream skinplate at hoist  
cables. Moderate corrosion on  
unidentified metal.

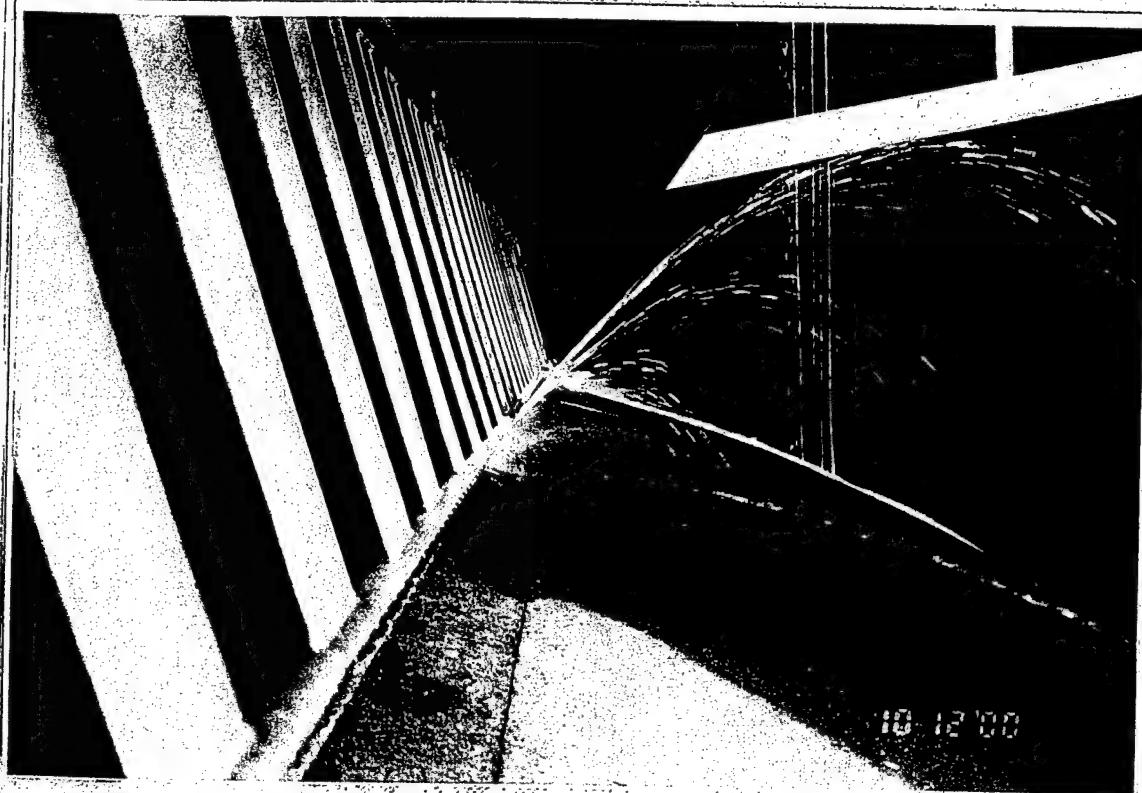
**Gate 4**  
Standing water between closure plate,  
purlin webs and skinplate, typical.  
Bottom right corner seal leak.

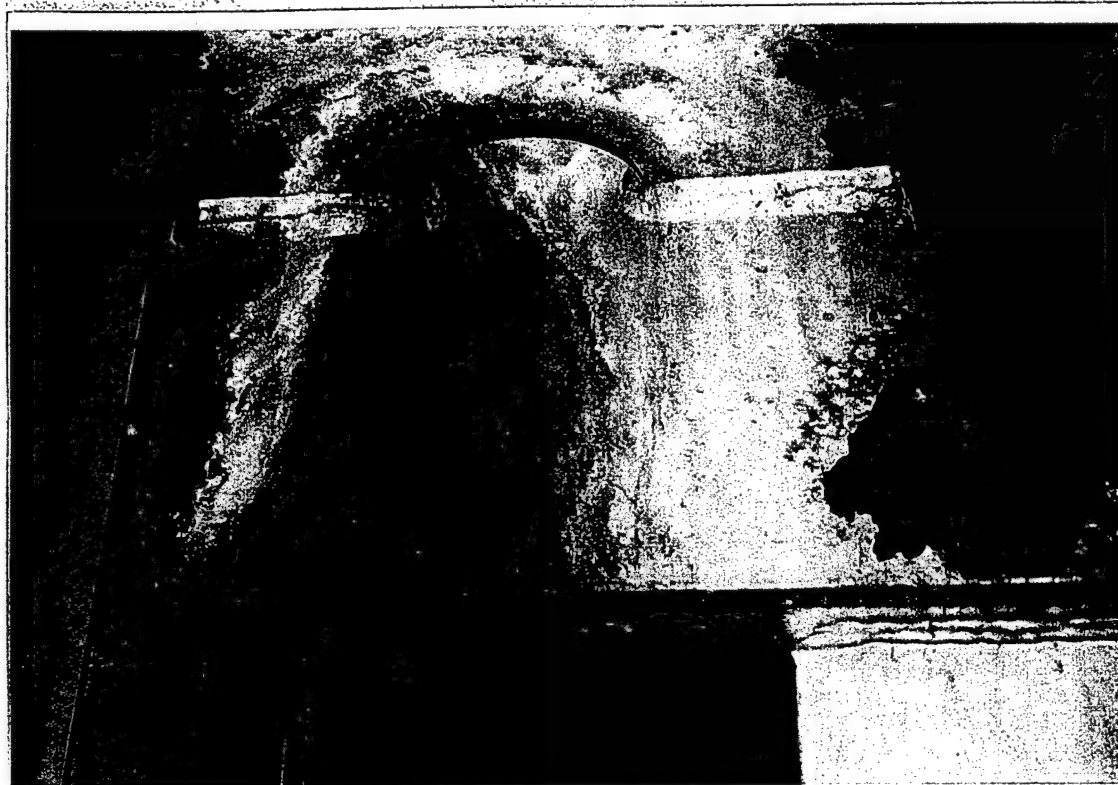
Bottom of bottom horizontal girder.  
Drain hole for upstream side of  
bottom horizontal girder. Light to  
moderate corrosion on surrounding  
members.

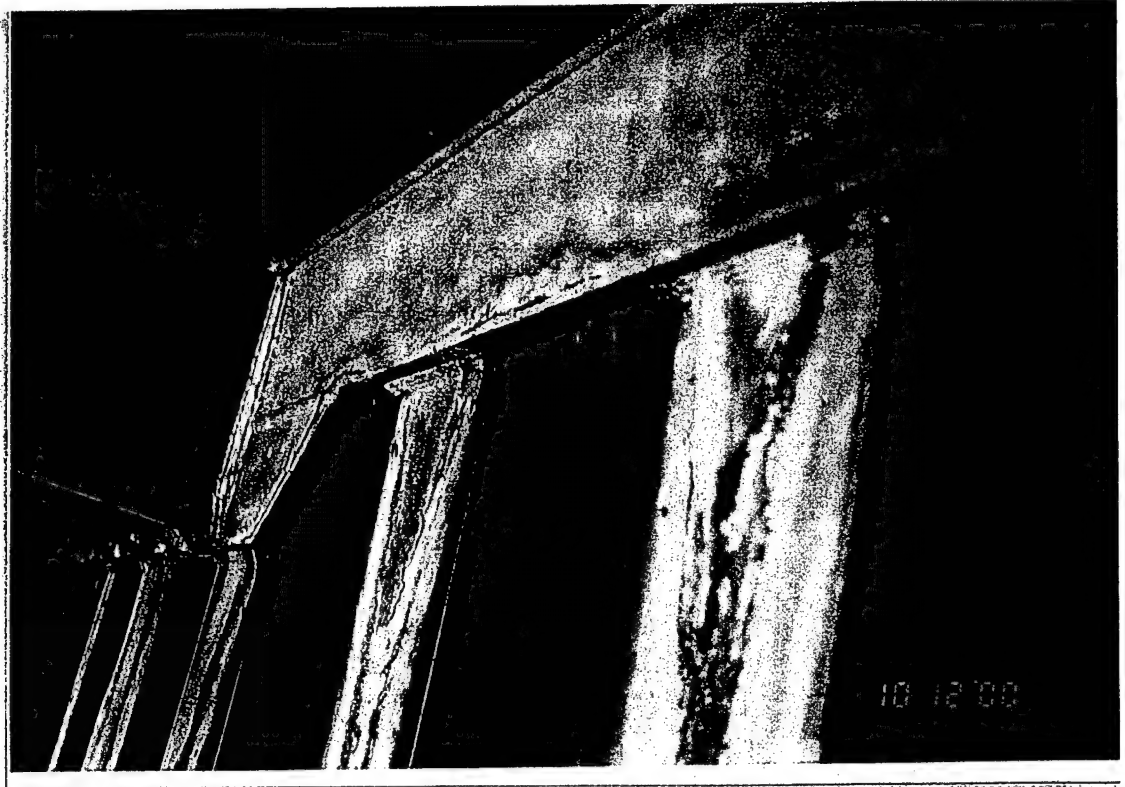
Bottom of bottom horizontal girder.  
Drain hole for upstream side of  
bottom horizontal girder. Light to  
moderate corrosion on surrounding  
members.
